# **Debris/Ice/TPS Assessment and Integrated Photographic Analysis of Shuttle mission STS-102**

**DEBRIS/ICE/TPS ASSESSMENT  
AND  
INTEGRATED PHOTOGRAPHIC ANALYSIS  
OF  
SHUTTLE MISSION STS-102**

**March 08, 2000**

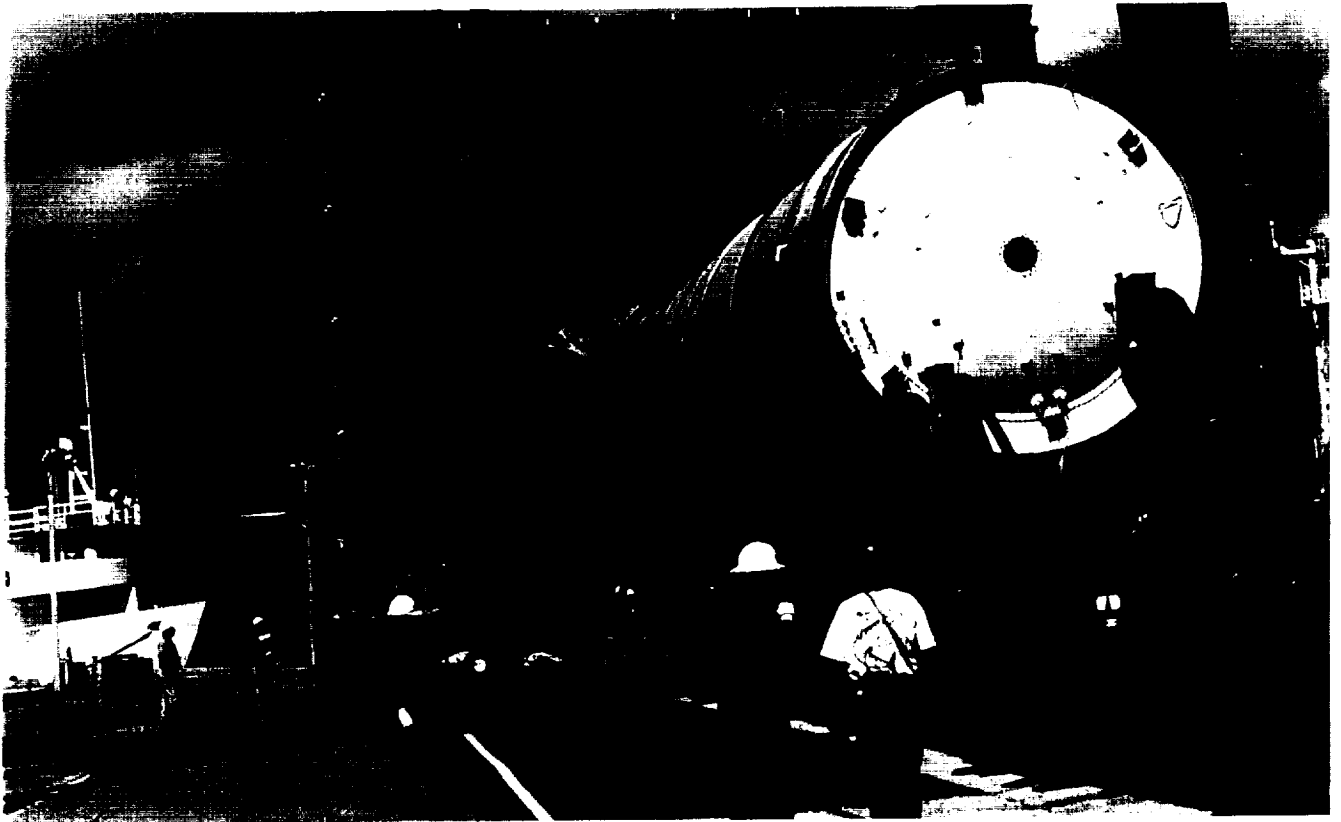
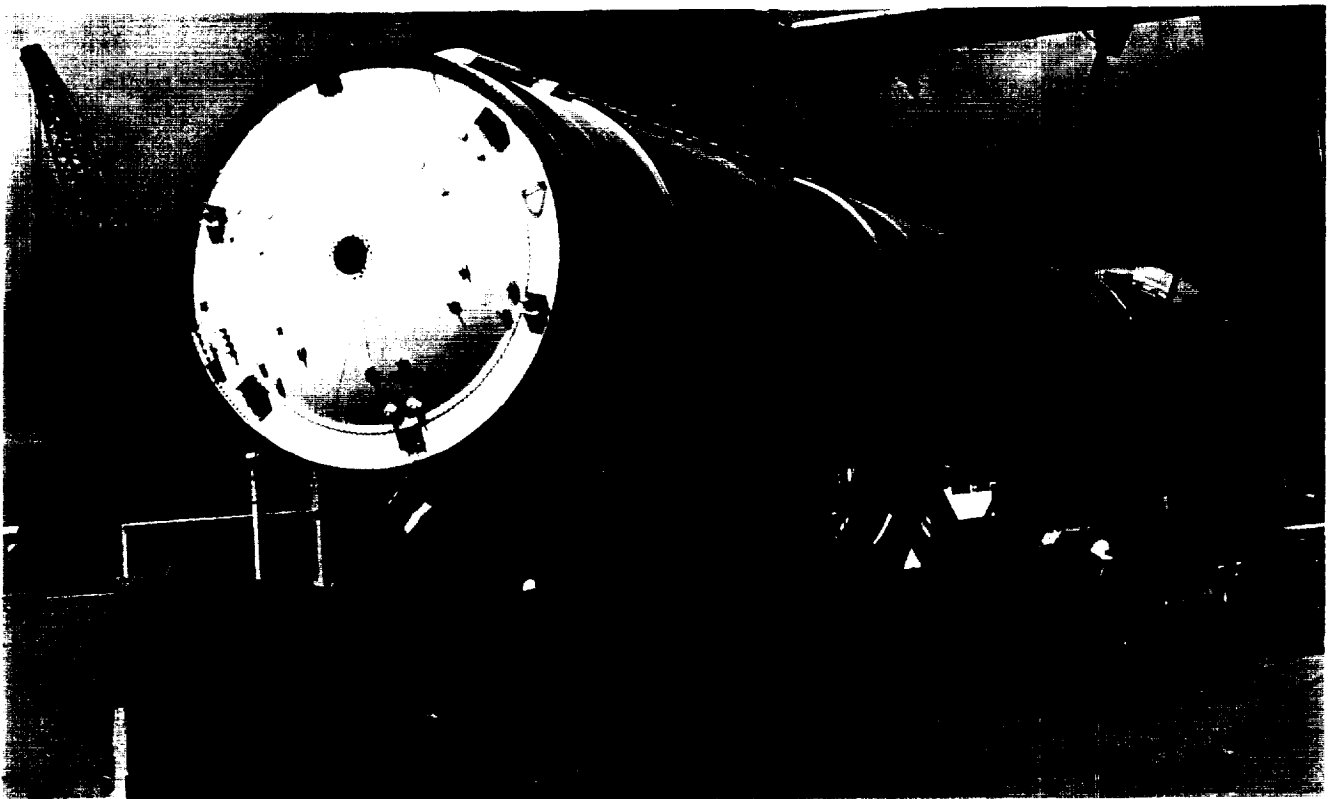
**Photo 14: SRB Post Flight Condition**

Both SRB's were found in good condition regarding debris assessment

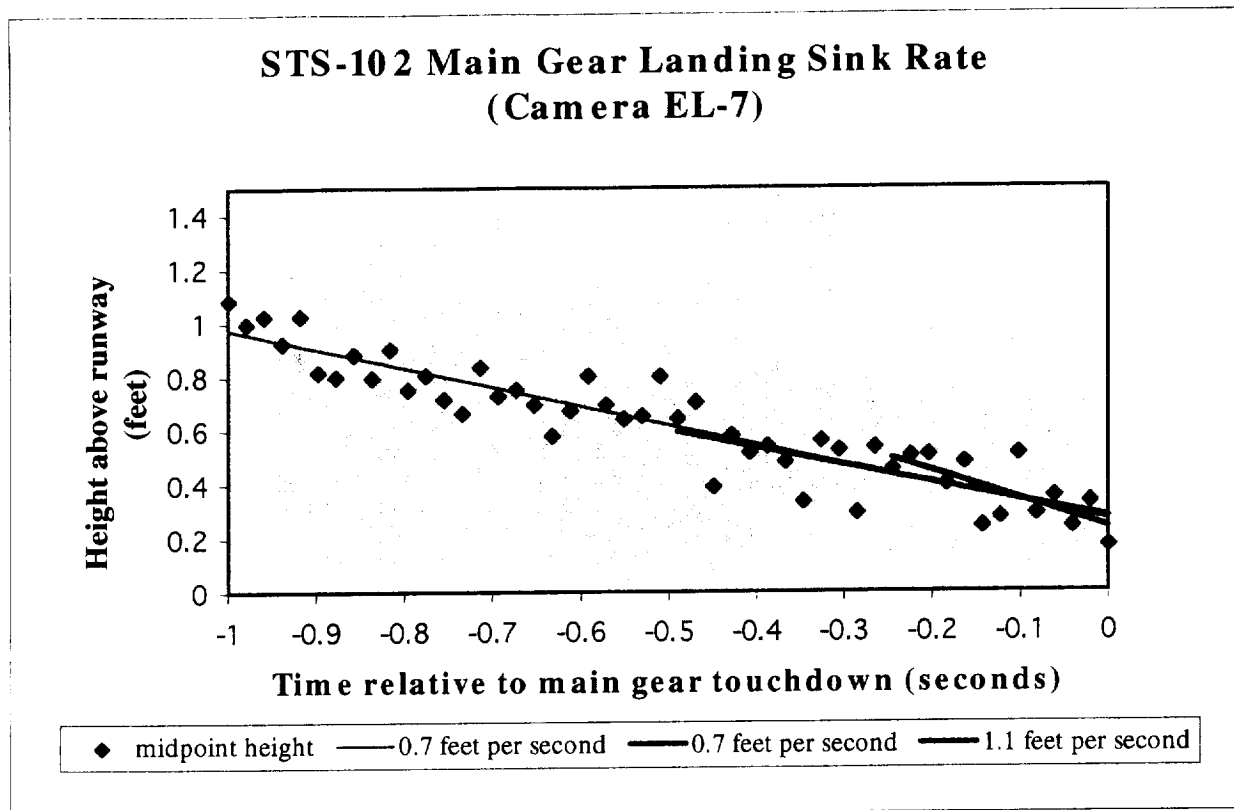
Figure 2.5 Main Gear Midpoint Landing Sink Rate

The maximum allowable main gear sink rate values are 9.6 feet / second for a 212,000 lb. vehicle and 6.0 feet/second for a 240,000 lb. vehicle. The landing weight of the STS-102 vehicle was reported to be 218,304 lbs.

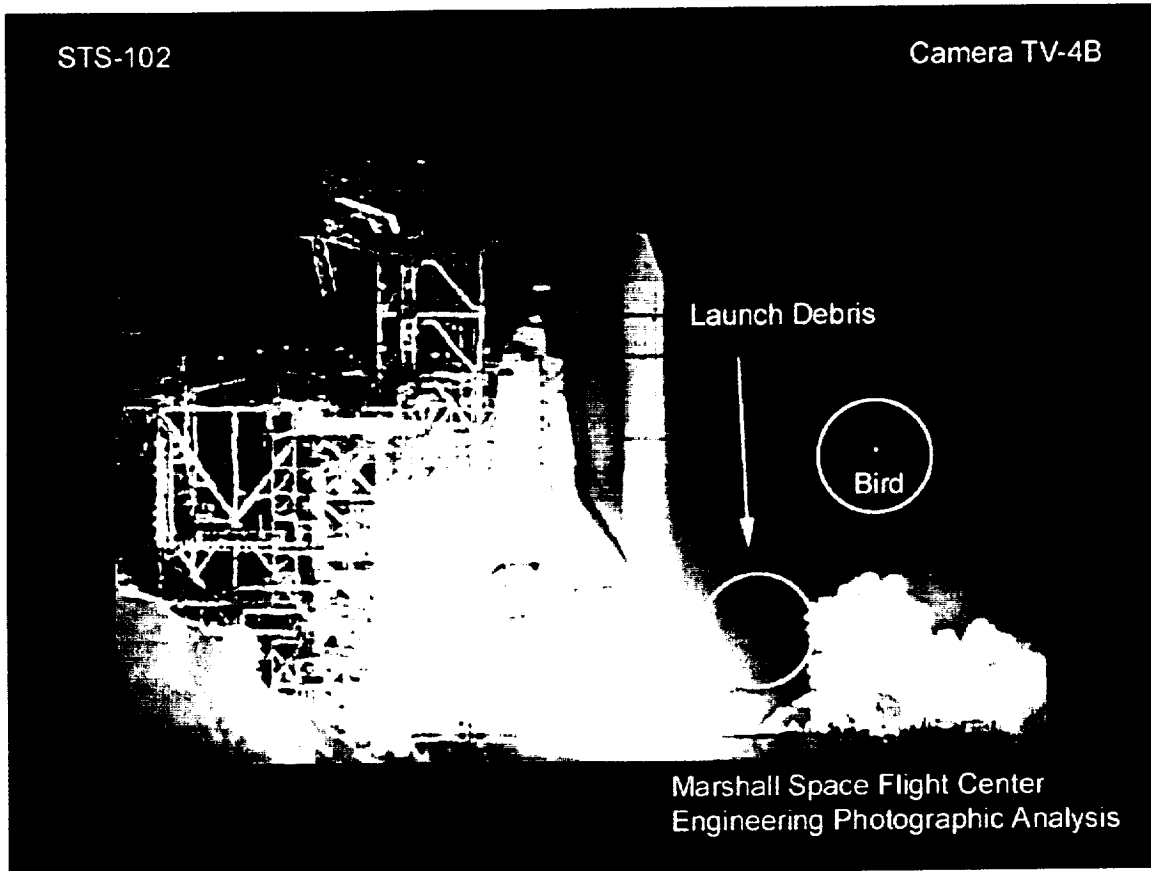
**Figure 2. Pad Debris at SRB Ignition**

Several typical launch pad debris items were observed at SRB ignition. A bird was also observed near the launch site.

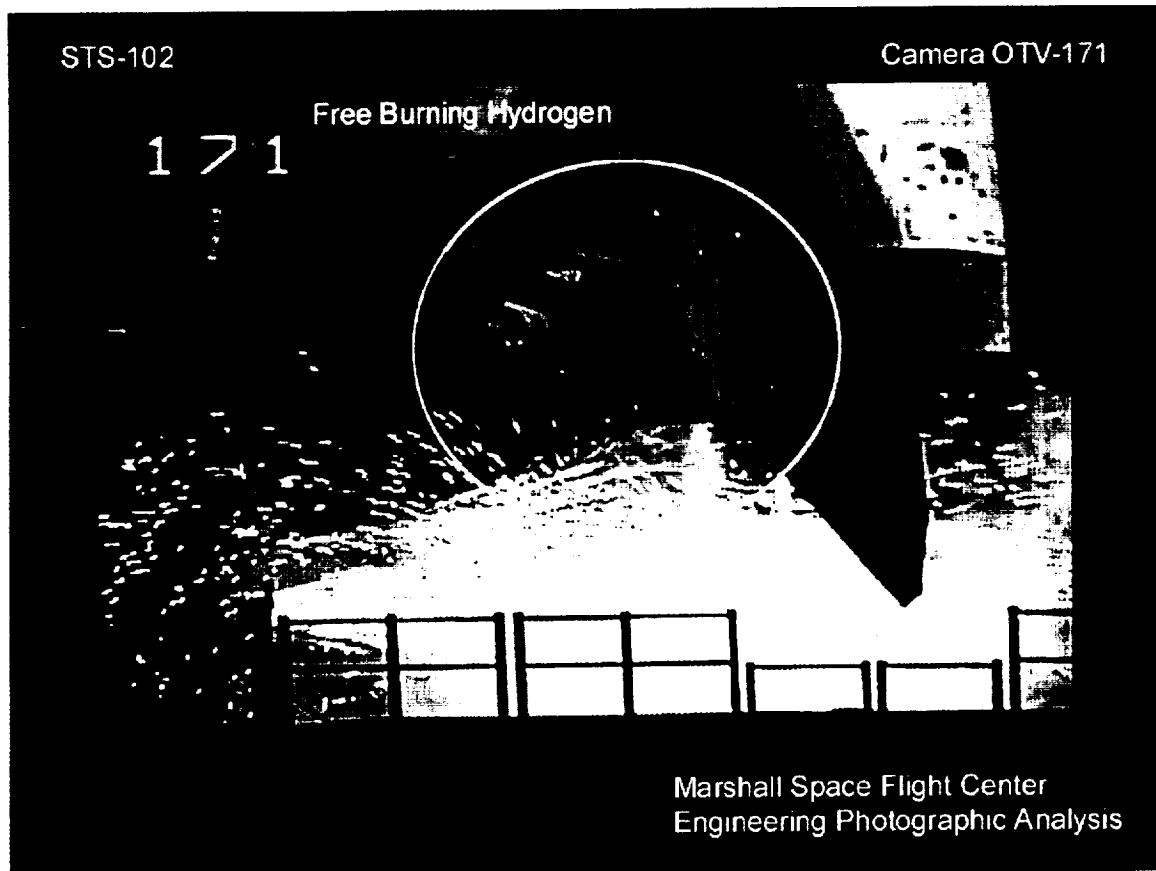
**Figure 4. Free Burning Hydrogen at SSME Ignition**

Free burning Hydrogen was observed at SSME ignition, extending forward of the -Y (left) OMS Pod rim. This particular phenomenon is a typical occurrence during SSME ignition and appears to be within normal limits.

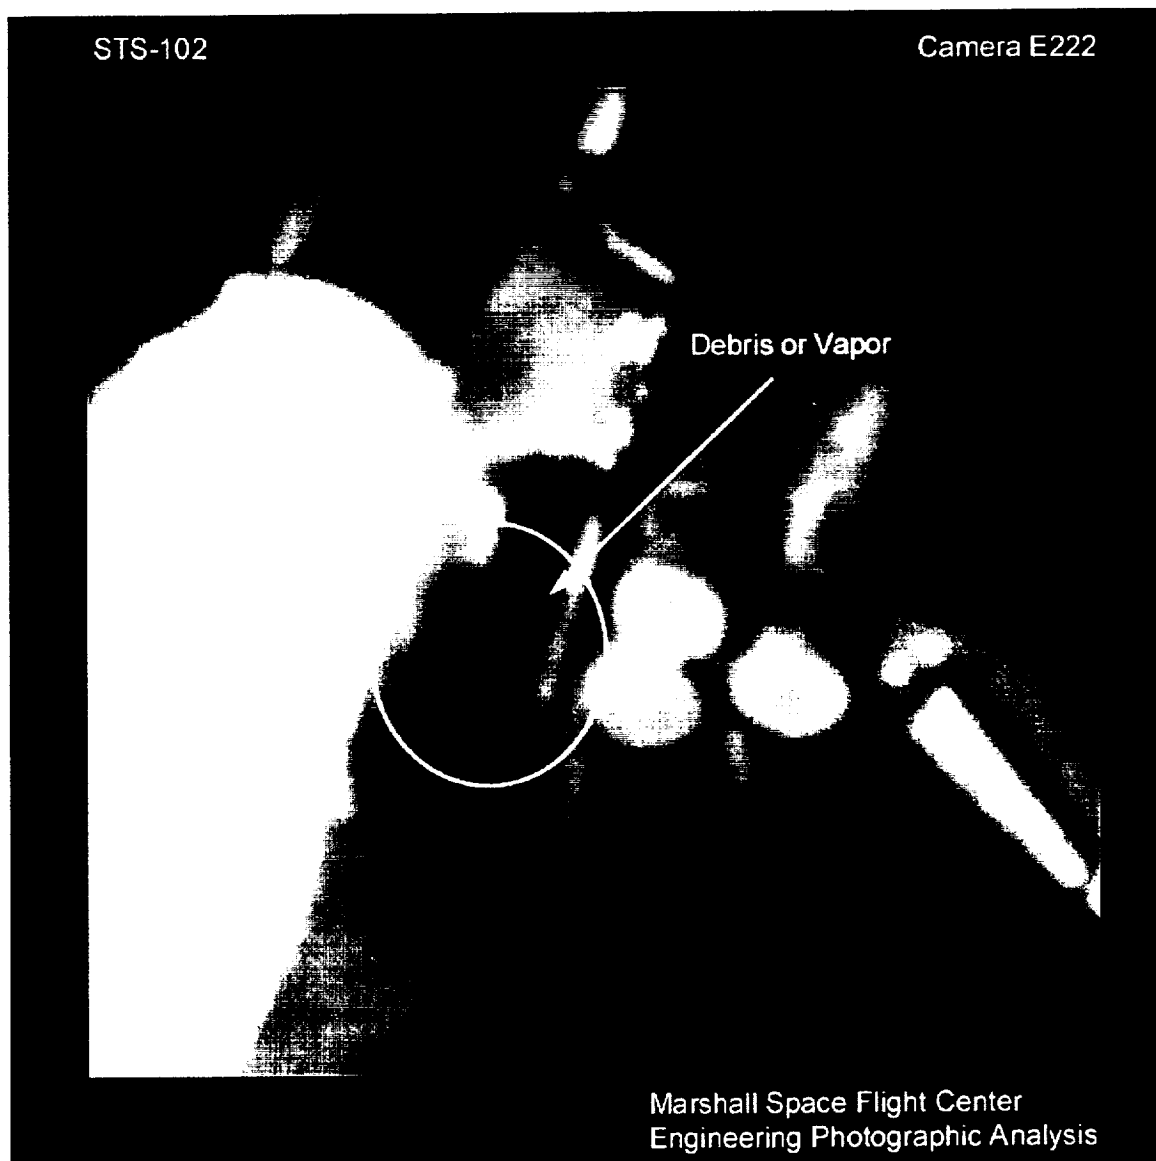
**Figure 14. Debris or Vapor Streak**

A possible debris or vapor streak was observed apparently between the Orbiter Body Flap and the SRBs.
